Central Interceptor Project

Assessment of Ecological Effects Associated with the Central Interceptor Project

Watercare

Boffa Miskell Limited

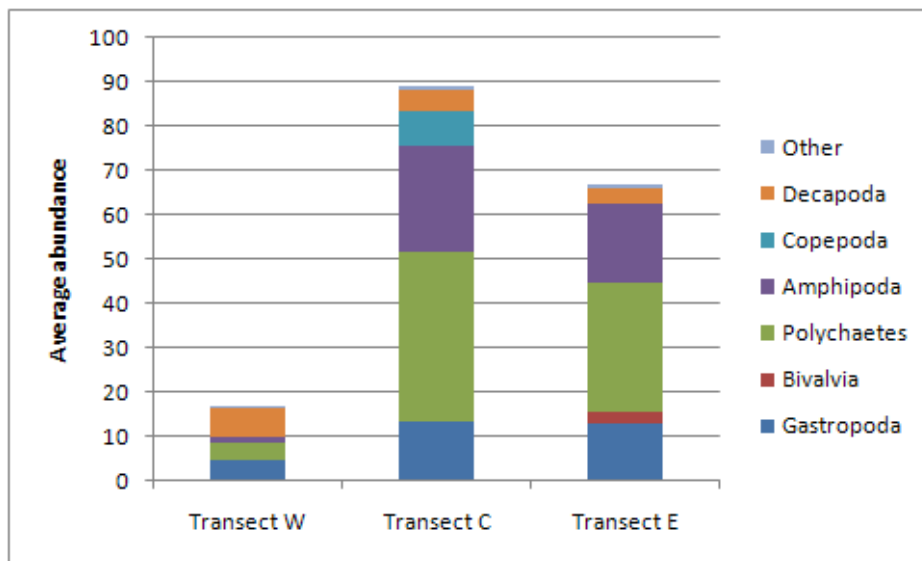
Figure 1: Average Abundance of Dominant Intertidal Taxa.

The western transect (Transect W) comprised mainly of decapoda (the tunnelling mud crab, *Helice crassa*), polychaetes (*Scolecopides benhami* and juvenile *Nereidae*) and gastropoda (*Potamopyrgus estuarinus*). No bivalves or copepods were recorded within this transect (Figure 1). Transect W had the lowest average abundance of infaunal taxa (Figure 1). Polychaetes, amphipoda and gastropoda were the dominant taxa in Transect E (eastern transect) (Figure 1). *Potamopyrgus estuarinus* was the dominant taxon of gastropod, the freshwater amphipod *Paracorophium* sp. was revealed in high numbers and *Scolecopides benhami* and juvenile *Nereidae* were the dominant polychaetes.

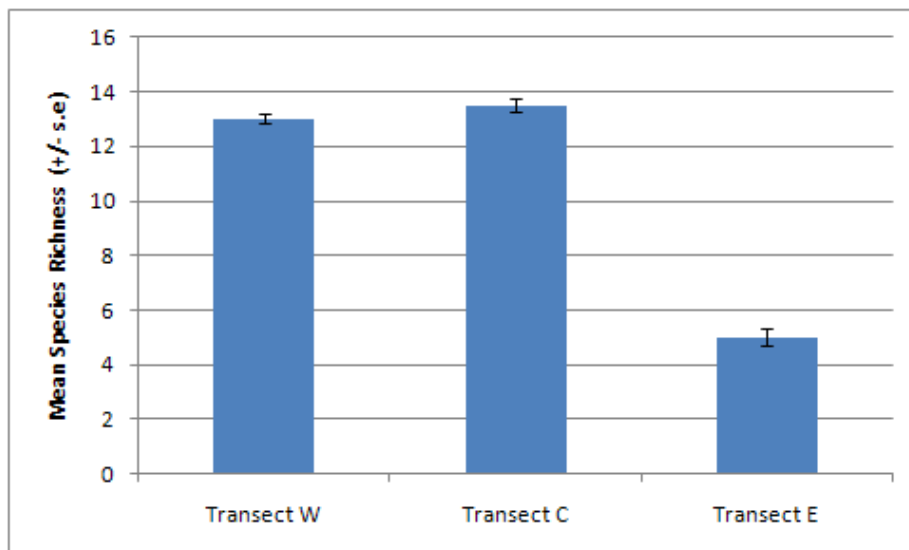
Figure 2: Mean Species Richness of Intertidal Infauna.

Of the six core samples that were collected during surveying, species richness ranged from 3 to 17. Mean species richness was greatest at Transect C (13.5) and lowest at Transect E (5) (Figure 2).

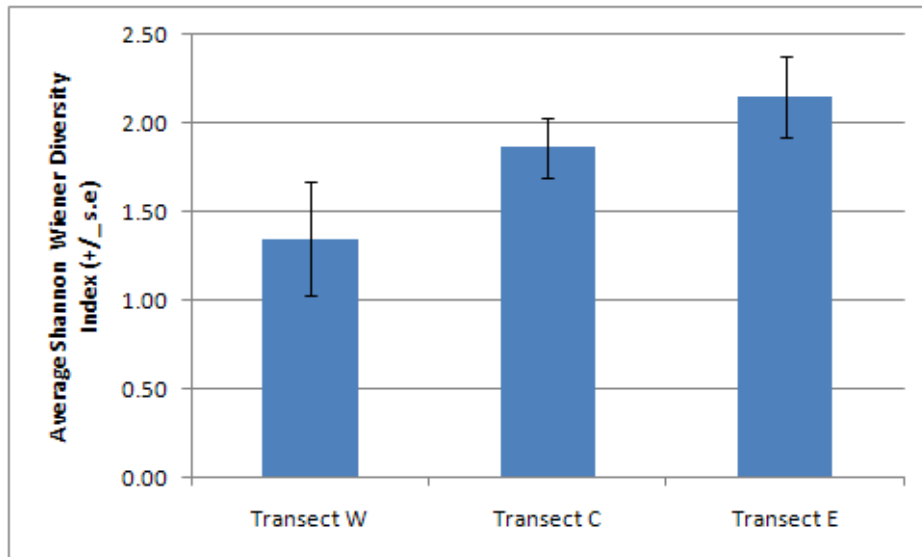
Figure 3: Mean Intertidal Infauna Species Diversity per Site.

The Shannon-Wiener Diversity Index ranged from 1.35 to 2.15, indicating a low to moderate level of species evenness and richness (Figure 3). The Shannon-Wiener Diversity Index was lowest at the Transect W site and highest at the Transect E site.

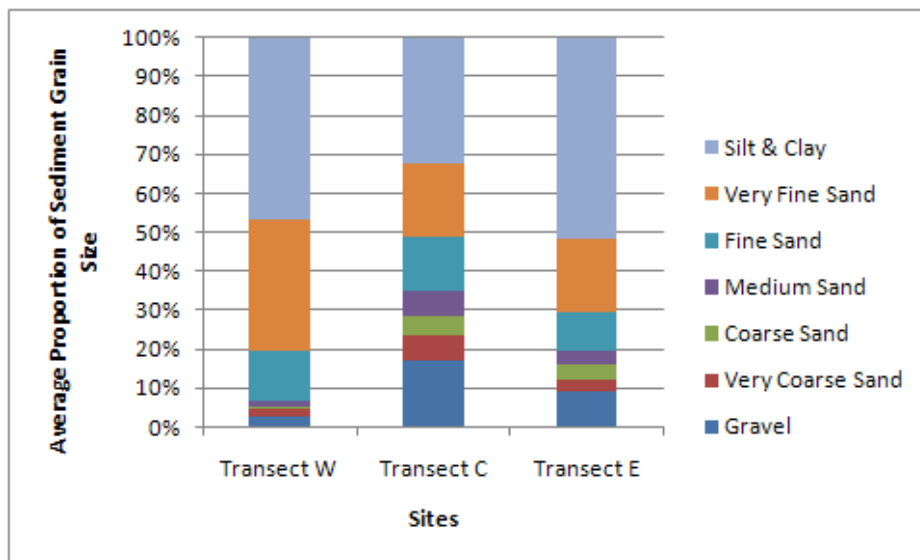
Figure 4: Intertidal Surface Sediment Grain Size Composition.

The results of the grain size analyses are given in Appendix 5. Composite samples analysed for sediment grain size showed a variety of size classes present across all transects. The average proportion of sediment grain size was comprised mostly of smaller sizes (fine sand to silt and clay (250µm - <63µm)). The average proportion of surface sediment grain size was dominated across all sites by silt and clay (Figure 4 and Table 5). Transect W revealed the highest proportions of fine sand through to silt and clay with < 10% consisting of coarse sand through to gravel. Transect C contained the highest proportion of gravel (17.2 %) and the lowest proportion of silt and clay (32.1%). Transect E revealed the highest proportion of silt and clay (51.6%).

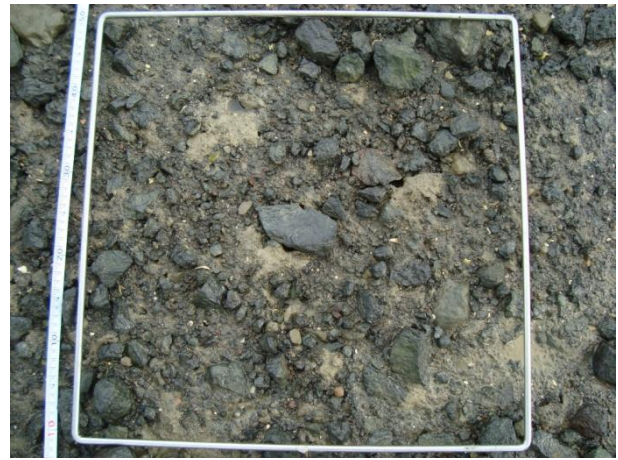
Plate 4: Intertidal benthic sediment – Western transect.

Quantitative sampling was undertaken in the intertidal area at Pump Station 23 (AS6). Benthic sediment differed between the three survey sites (see Appendix 3): the Western Transect (Transect W) was characterised by gravel and cobbles which altered abruptly at approximately 18.5 m to a fine sand substrate; the Central Transect (Transect C) consisted of gravel and sand which then changed to a sandstone reef from approximately 20 m onwards; and the Eastern Transect (Transect E) was characterised by fine mud approximately 2 to 4 cm deep over sandstone. The shallow nature of the sediment caused some difficulty in gathering sufficient core samples.

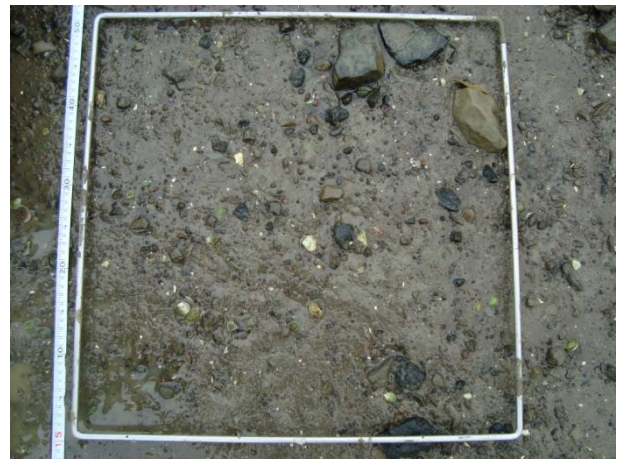
Plate 6: Intertidal benthic sediment along Central transect.

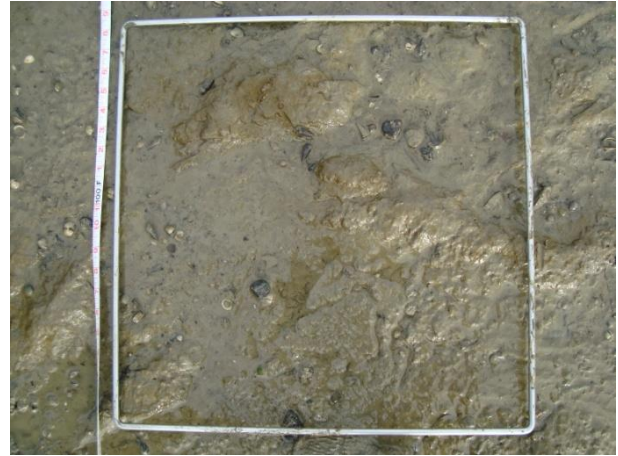
Plate 8: Intertidal benthic sediment along Eastern transect.

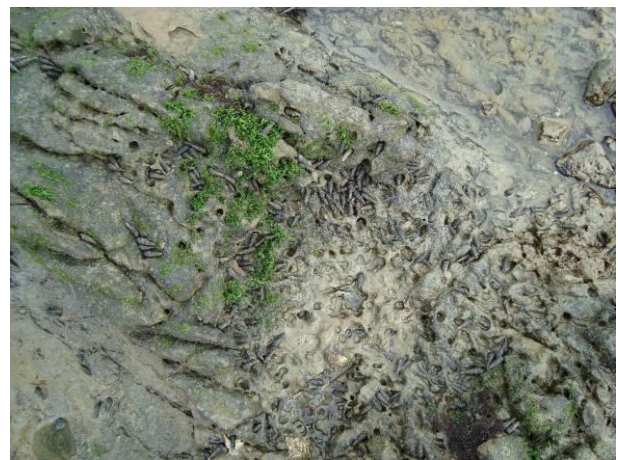
Plate 10: Close-up of sandstone reef showing *Zeacumanthus lutulentus* and green algae.

Dominant epifauna taxa noted in the survey quadrats were *Zeacumanthus lutulentus* and *Potamopyrgus estuarinus*. *Z. lutulentus* was very abundant within the crevices and holes provided by the sandstone reef. There was a noted absence of *Cominella glandiformis*, a common mud whelk. Crab holes were noted in several of the quadrats but were largely absent where the substrate was comprised of sandstone overlain by mud.

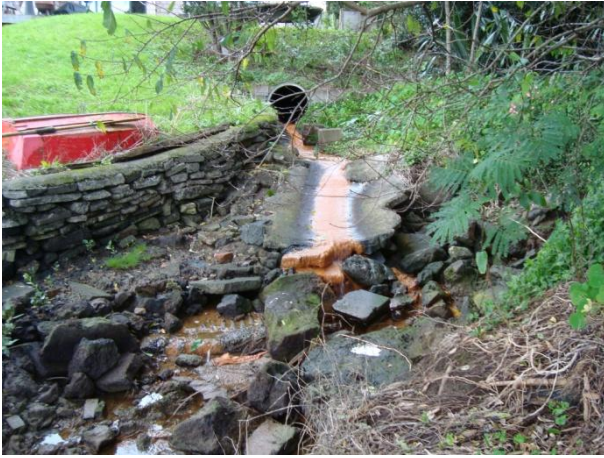
Plate 11: Stormwater outlet leading out to estuary area.

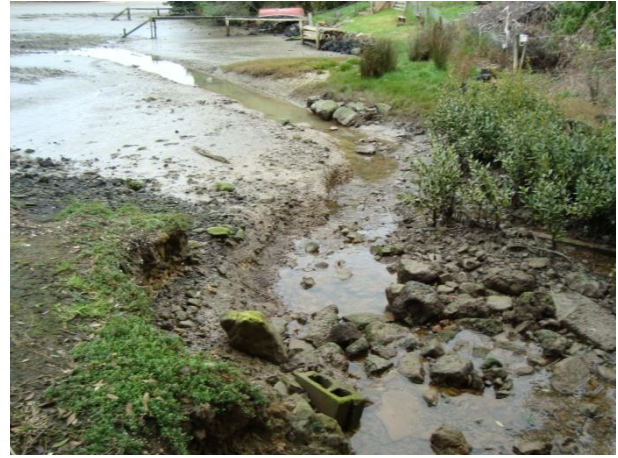
Plate 12: Channel from stormwater outlet leading into the estuary.
