**Ref** 19685

Subject - Arboricultural memornadum

Lyon Avenue, St Lukes

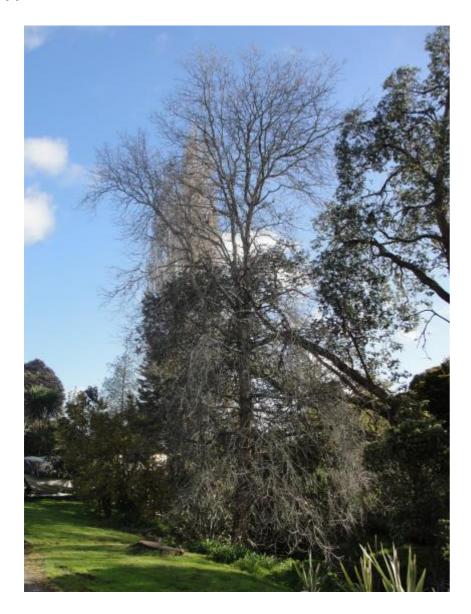
Photo 1: Tree 1. Pin oak

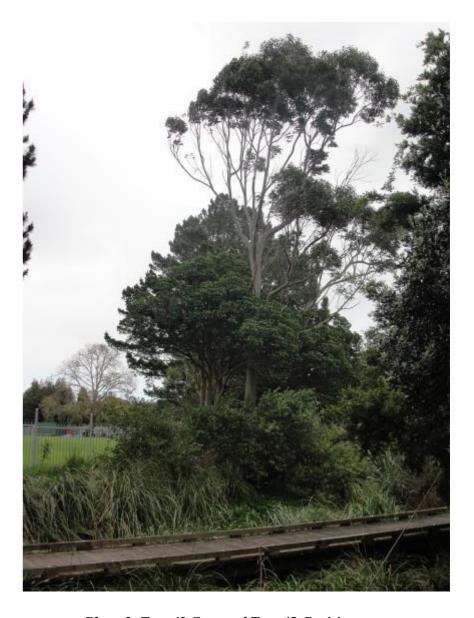
Photo 2: Tree 43.Gum and Tree 45. Puriri

- 5.3. In addition, it is likely that trees 43 45 will also require removal to facilitate the various earthworks and proposed bridge structures.
- 5.4. In total, option 2 will require the removal of 54 individual trees and 240 square metres of mixed native vegetation, as well as works within the root zone of at least 17 individual trees.

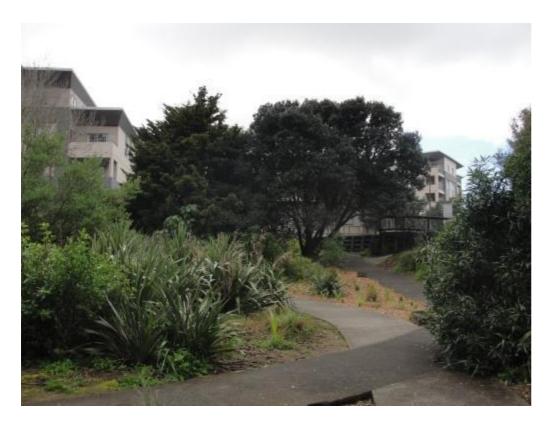
Photo 3: Tree 36. Totara and Tree 37. Pohutukawa

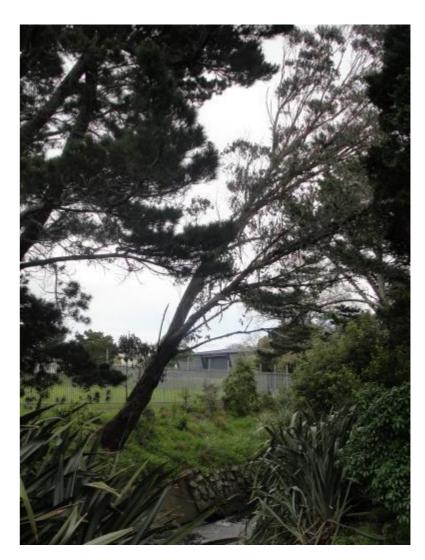
Photo 4: Tree 23. Gum

- 5.2. The option to install the connecting tunnel by means of open trenching will require a large excavation of some 5 8 metres deep. Excavations of this magnitude in proximity to trees can often result in the removal of multiple roots. Trees 22, 23 and 24 will be most affected by the trenching. Tree 24 is located directly within the footprint of the proposed trench alignment and so removal of this tree will be required. The excavation will pass approximately 3 metres from the base of tree 23 and 5 metres from the base of tree 22. These excavations will be on the periphery of the critical root zones of each tree, within which the structural root system is anticipated to be encountered. The removal of structural roots is likely to have an adverse effect on the stability of each tree, thus their removal will be required should the trenching option be pursued.

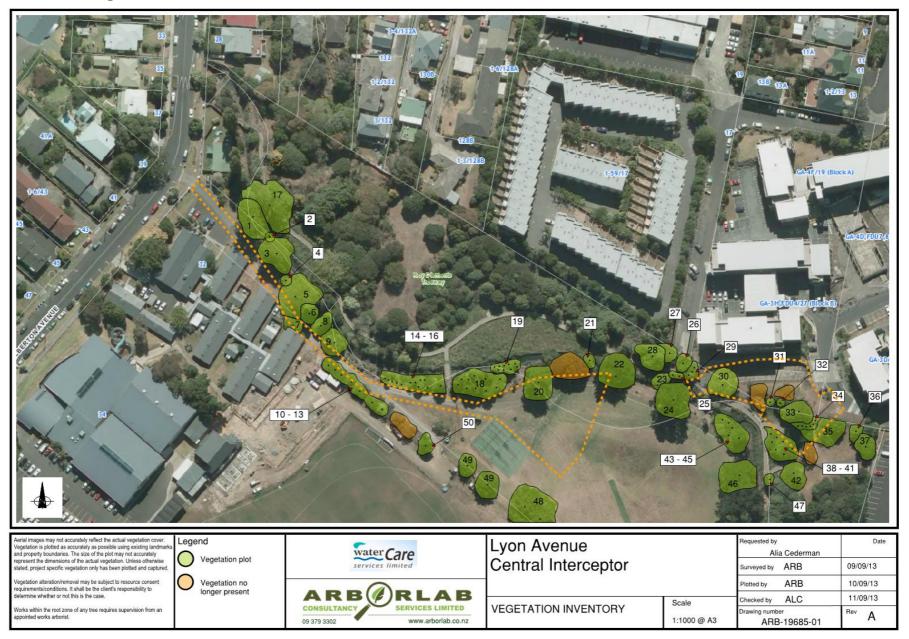
- 4.1. The option to construct the connecting tunnel using a pipe jack method is depicted on the drawing LYON-SK1001 as well as ARB-19685-01 which shows the various vegetation plots.

- 4.3. Option 1 requires the removal of 46 individual trees, as well as approximately 240 square metres of mixed native vegetation. It is identified that these 240 square metres of vegetation can be described as un-managed and of low quality when considering species diversity and overall plant health.

- 4.4. In addition, option 1 requires that various works will need to be undertaken within the root zone of at least 19 individual trees. These works are likely to involve various excavations as well as machine tracking.

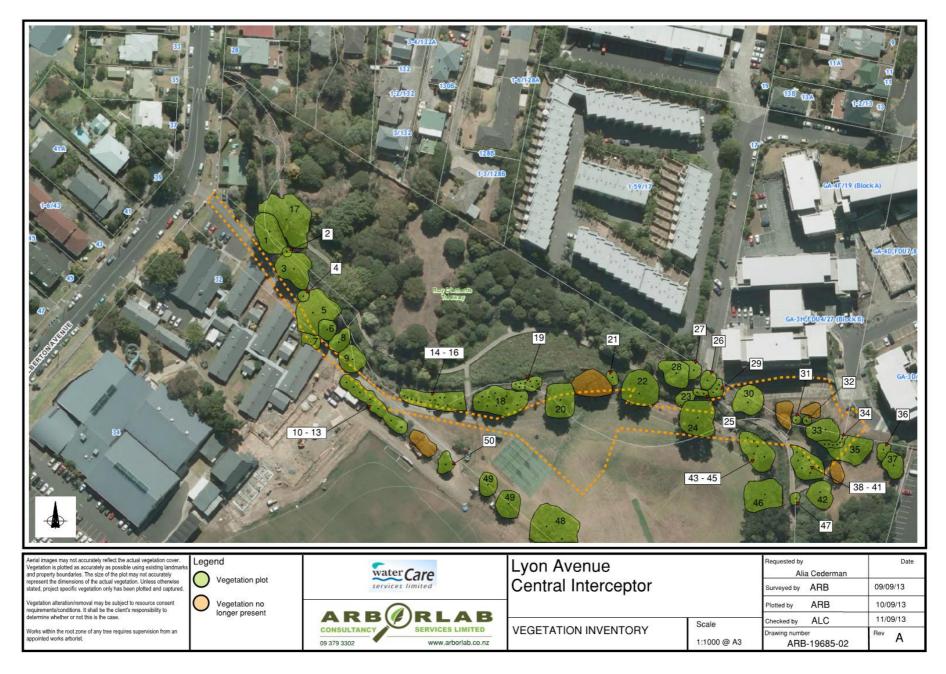
- 5.1. The option to construct the connecting tunnel using an open trenching method is depicted on the drawing LYON-SK1101 as well as ARB-19685-02 which shows the various vegetation plots.

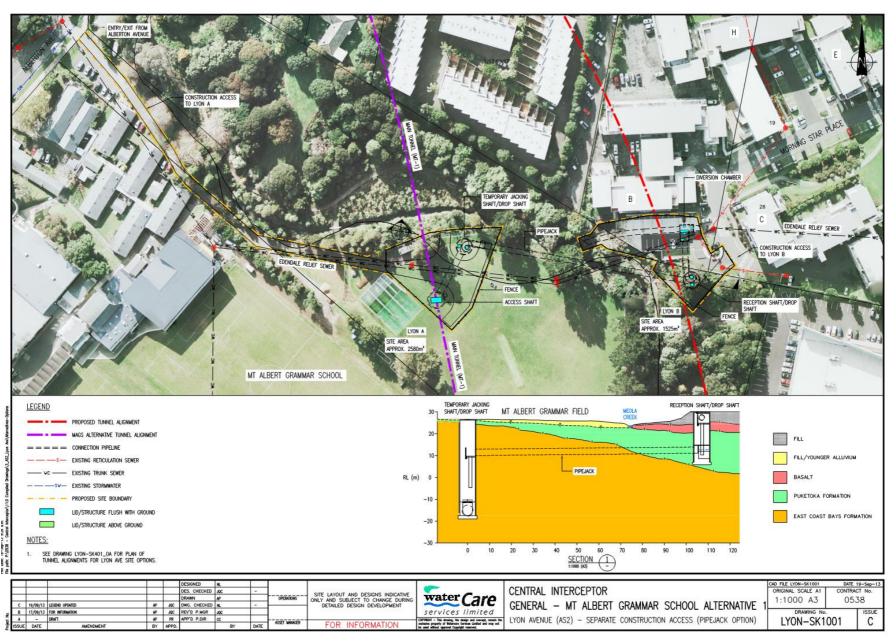
- 4.2. The option to pipe jack the connecting tunnel negates the requirement to install the connection by open trenching, thus any adverse effects to vegetation associated with the additional earthworks would be eliminated.
